U.S. NAVY SALVAGE REPORT

USS *MISSISSINEWA*

OIL REMOVAL OPERATIONS

MAY 2004

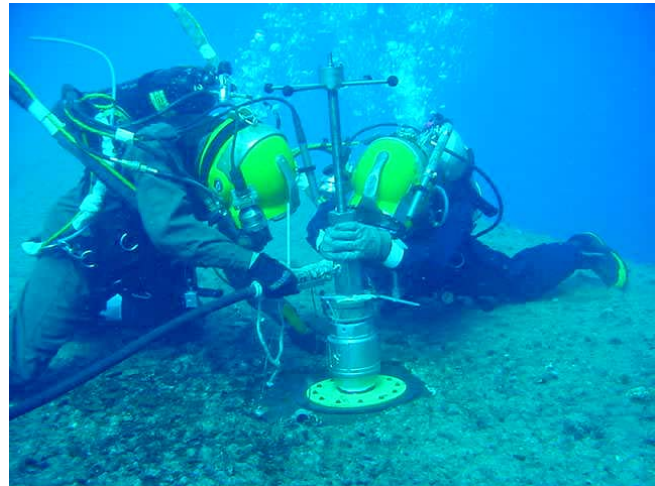
Figure 4-8. Two Divers Working the Hot Tap Machine on *Mississinewa*'s Hull

Mississinewa's hull was in remarkably good shape, considering that it had been on the seafloor for 59 years. It was encrusted with a 1½-inch thickness of marine growth, which divers broke away with chipping hammers and cleaned with grinders to expose an area of approximately 9 square feet to make way for each hot tap. One team of divers cleared the work area for the hot tap, often clearing two or three such areas before the end of their dive. The next dive team would mount two or more flanges for the hot tap equipment. A third team would accomplish the hot tap, attach the pump hose, and signal readiness to commence pumping. Pumping operations were always started with divers on station to observe the initial pumping for any signs of leaks or other problems. Once system integrity was confirmed, divers could undertake additional tasks or return to the surface. Figure 4-8 shows a view of two divers with a hot tap machine on *Mississinewa*'s hull.

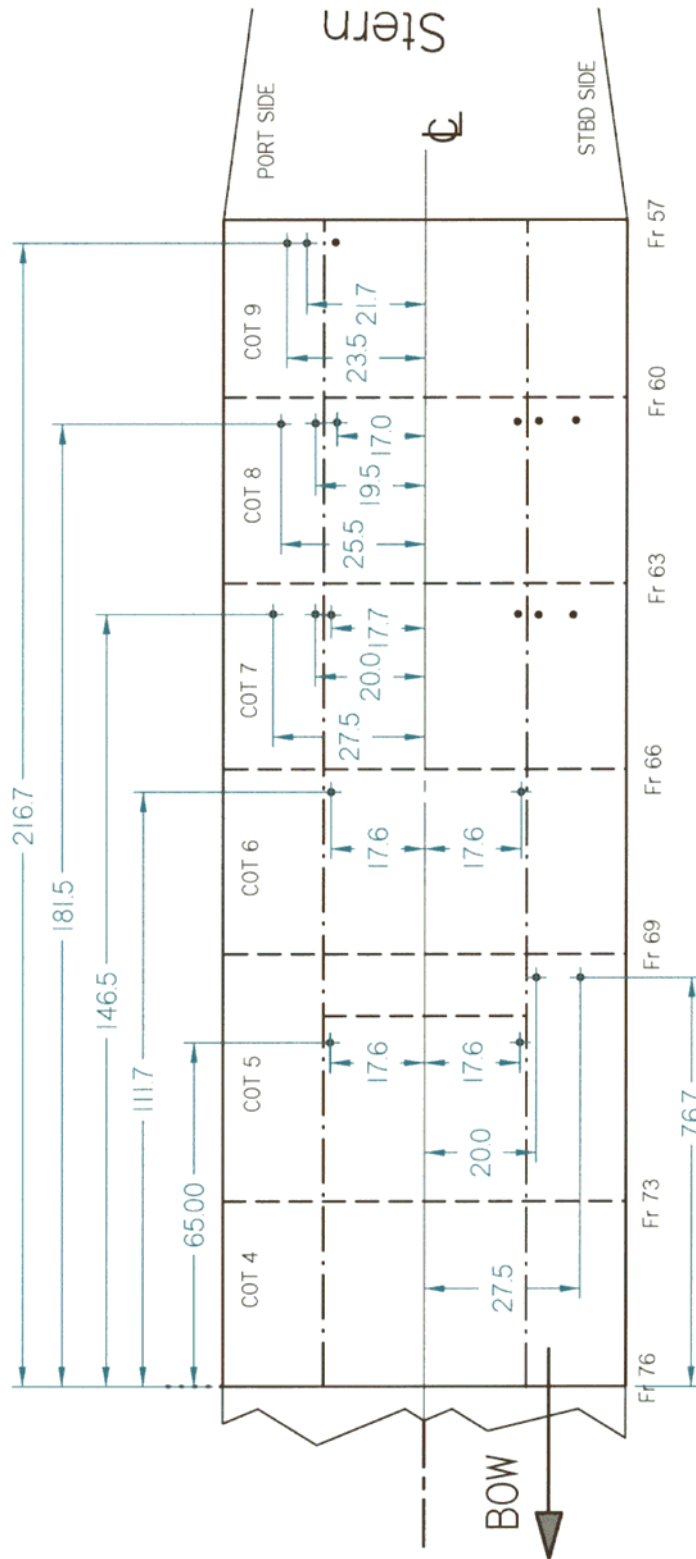
Figure 4-9. Cargo Tank Locations

The locations for the planned taps on the main cargo tanks are laid out in Table 4-2. These points were identified as the highest tank point as the vessel now lies and the closest flat-plate location based on the shell-plate expansion drawings. These dimensions are also shown on the sketch in Figure 4-9. A wire grid was fabricated to assist divers in locating these positions. The following details describe the grid:

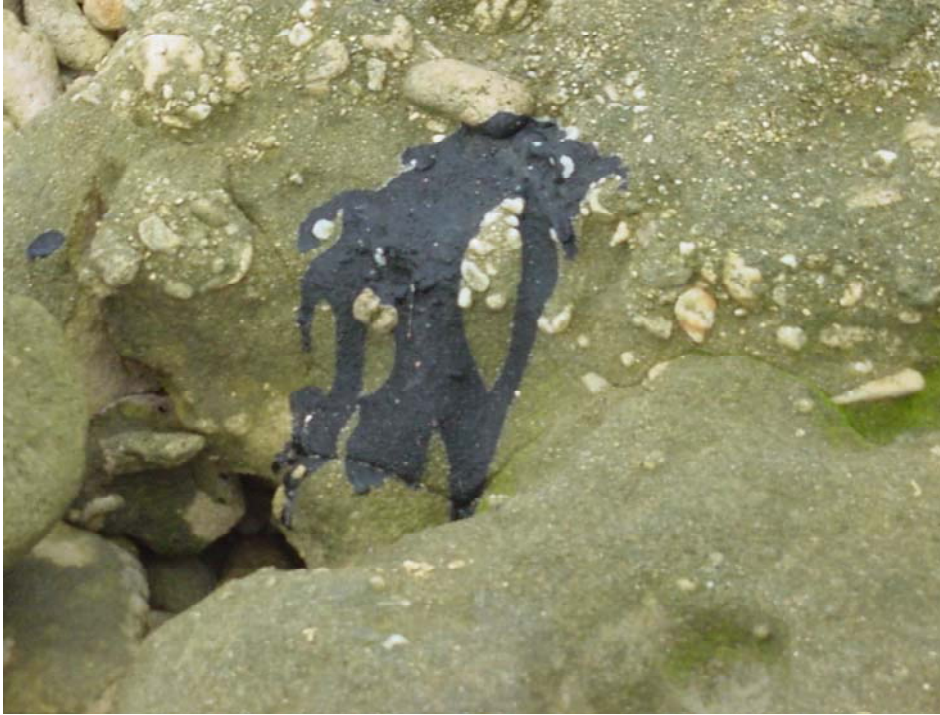
Only in a few areas was any sign of oil found. Considerably less oil was found than had been previously reported by the Yap Government and the subsequent USCG surveys. Recent storms with winds exceeding 35 knots had likely scoured the beaches of any significant remaining oil. There was no evidence that oil was buried. The largest oil deposits observed were from smaller than an inch to several inches across. The distance between patches was from 3 feet to 10 feet over a typical distance of 100 feet on a single exposed beach. The largest deposits were found on Falalop Island. Most beaches were oil free. The oil that was found consisted of a few isolated weathered patches. Figures 6 and 7 show typical remaining oil deposits.

Figure 6. Oil Patch, 4" Across – Falalop Island

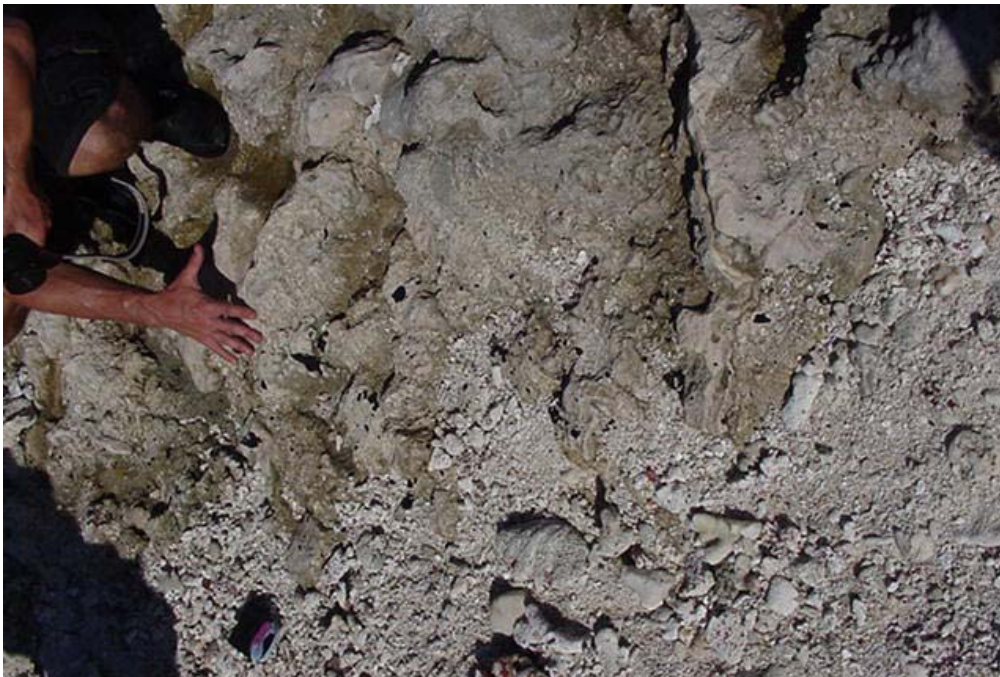
Figure 7. Scattered Oil Deposits – Asor Island

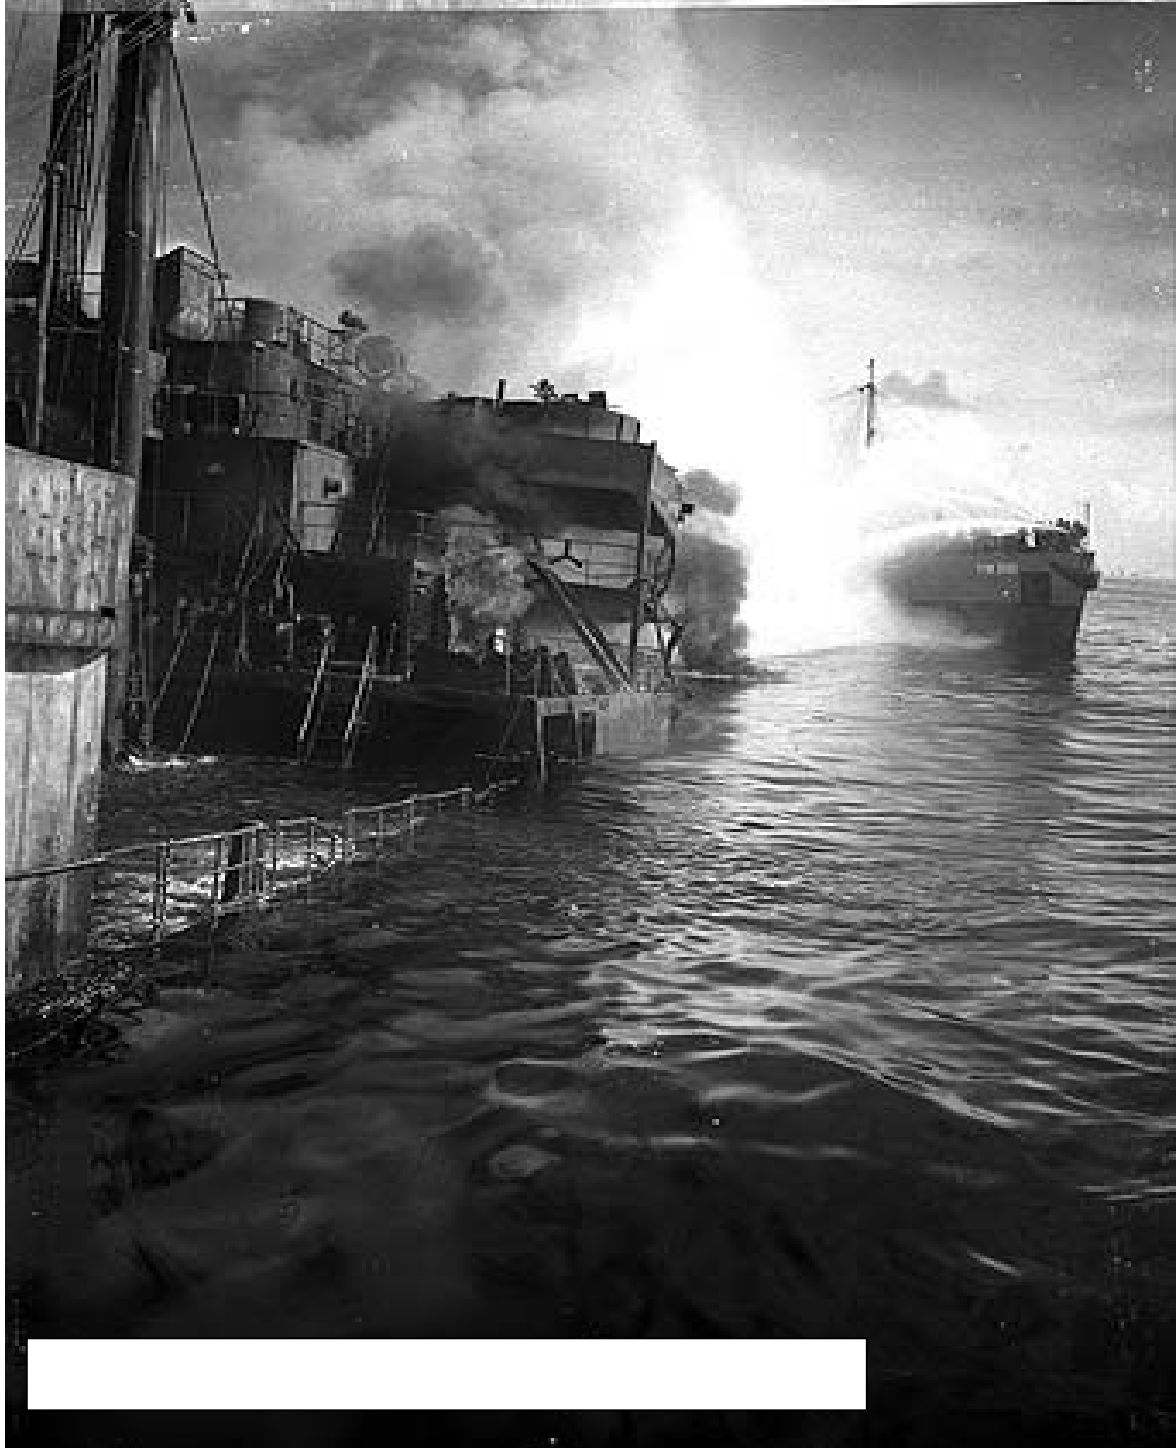
With a working model of the AO 59 developed, POSSE's Salvage subroutine was used to imitate the likely torpedo damage and sinking of the ship through progressive flooding and eventual rollover. The Sid Harris photographs, showing AO 59 upright with her decks awash with the bow under, suggest that the ship still had positive GM even as it was going under at the bow. This condition is matched in successive POSSE runs by assuming initial torpedo damage (TORPEDO.SAL), then allowing progressive flooding of the focsle spaces and downflooding of the Forward Pump Room and Ammunition spaces in the forebody (DWNFLOOD.SAL). Progressive flooding of the Midships Pump Room, via the Pump Room House and its ventilation ducts and possible backflooding of the No. 6 P/S SWB/DOT (PHOTO-C.SAL), brings the ship's trim to a condition similar to that shown in the Sid Harris photograph (see Figures A-1 and A-2).

Figure A-1. Sid Harris Photo of *Mississinewa* – Going Down by the Bow

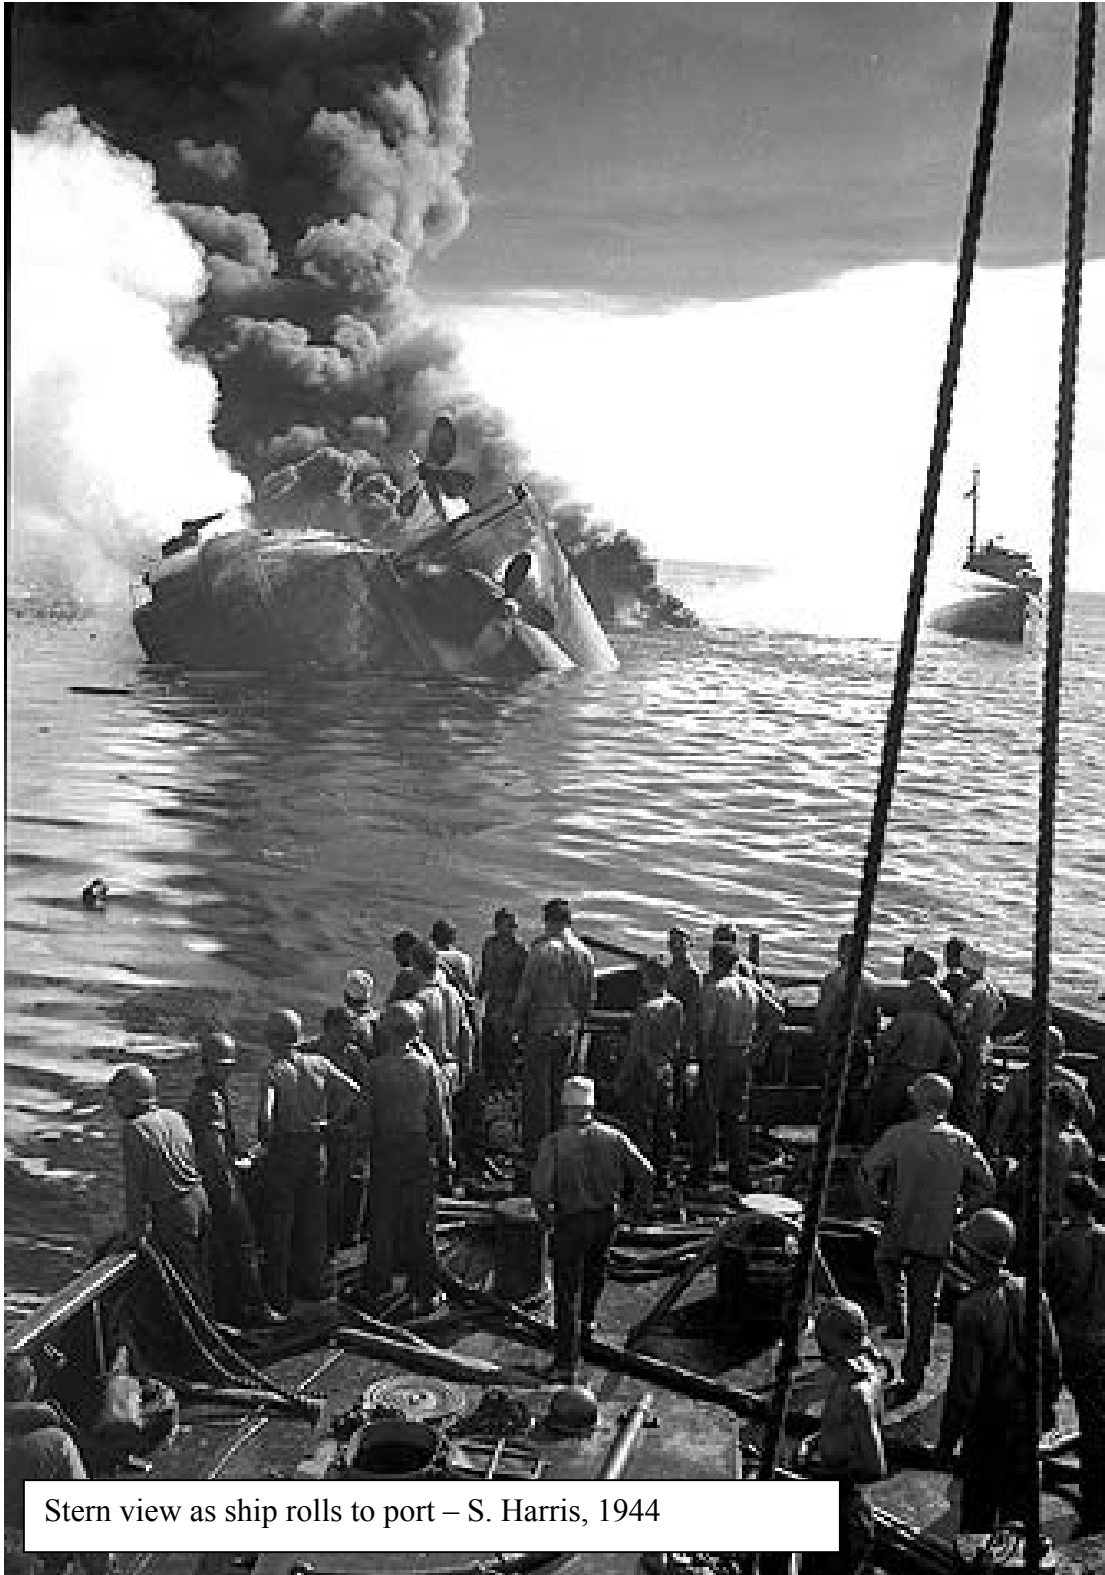
Even in this condition, POSSE indicates that the ship has a range of positive stability between 0 and 25 degrees. It is speculative whether the ship capsized first from Engine and Boiler Room downflooding and accumulated firefighting water on upper decks (see CAPSIZE.SAL), or the roll was completed when the bow hit bottom in 130 feet of water (at a vessel trim of about 15 degrees by the bow). This latter condition (see ROLLOVER.SAL) has the capsize roll generated by the coral reaction at the bow, which would have twisted the bow to port. The remainder of the ship could have completed its roll as shown in the dramatic Sid Harris photograph (see Figure A-3) with the propellers up and the ship rolled 135 degrees or so to port.

Figure A-3. Sid Harris Photo of *Mississinewa* – Stern View as Ship Rolls to Port

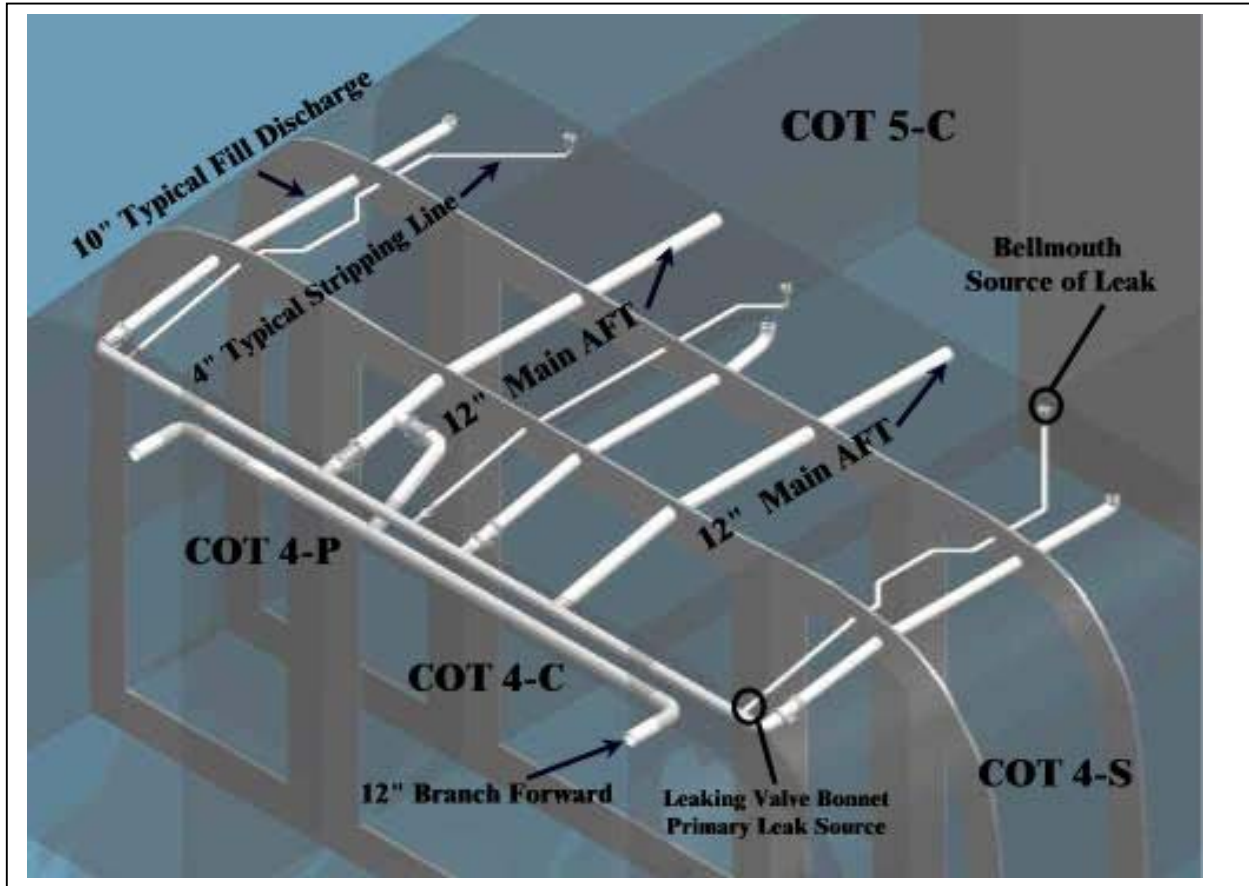
Solid Edge is a powerful 3-D parasolid modeling computer program used to simulate any three-dimensional object or assemblage of objects. Figure A-4 shows a model of the piping in COTs 4-P/C/S. This figure has been annotated to show where the leak sources were encountered as described in the front sections of this report.

Figure A-4. Model of Cargo Oil Tank #4

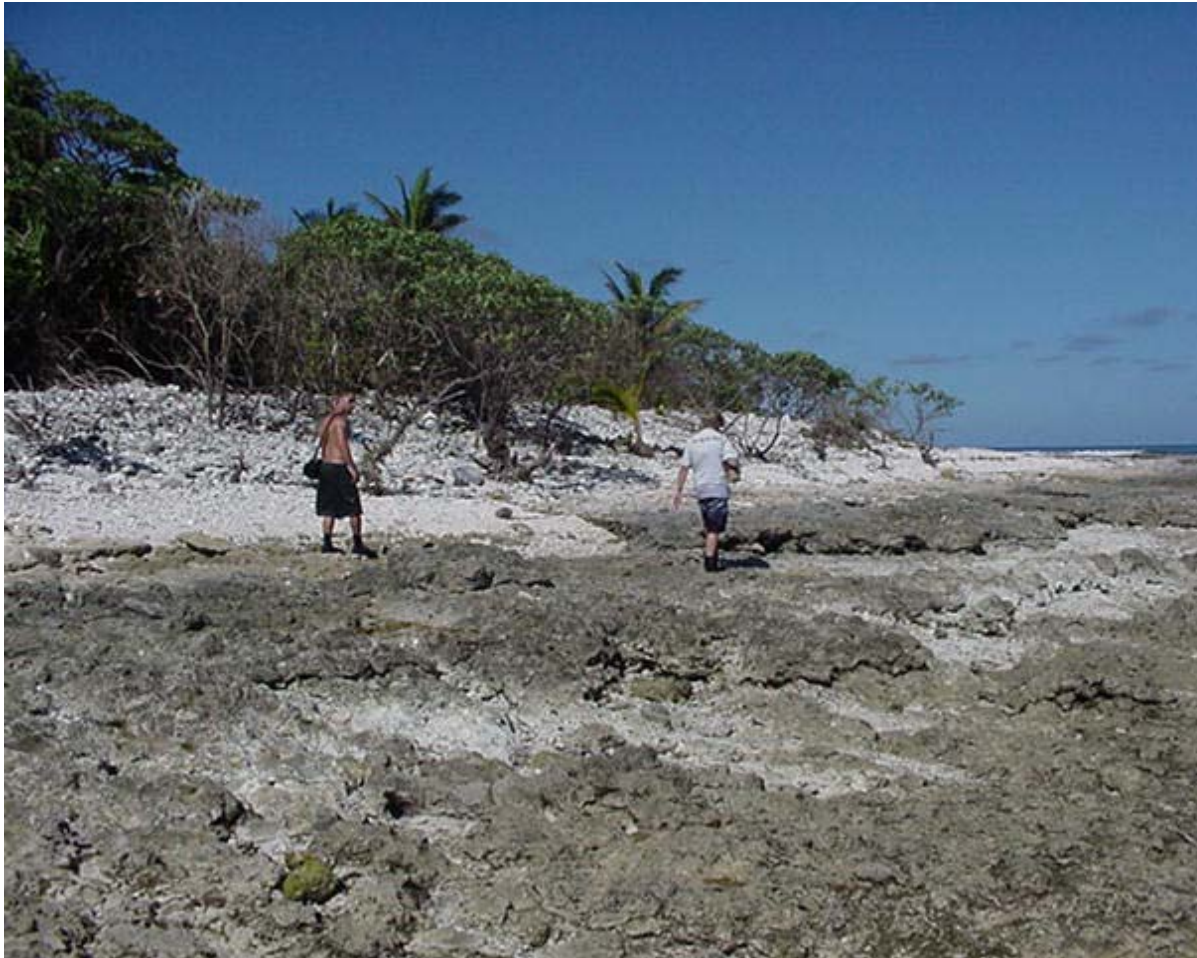
The southwest beaches of Asor Island, facing the wreck site, were surveyed (approximately 3/4 mile). There are rock ledges on the southeast end of Asor along the beach, see Figure C-2. These beach ledges are impacted by a perpendicular wave pattern along the beach, caused by the channel tidal flow. These ledge-flats at low tide did not exhibit any significant oil deposits. The largest oil deposits found were from the size of a dime to no larger than a quarter. The distance

Figure C-2. Beach Ledge – Asor Island Southeast End

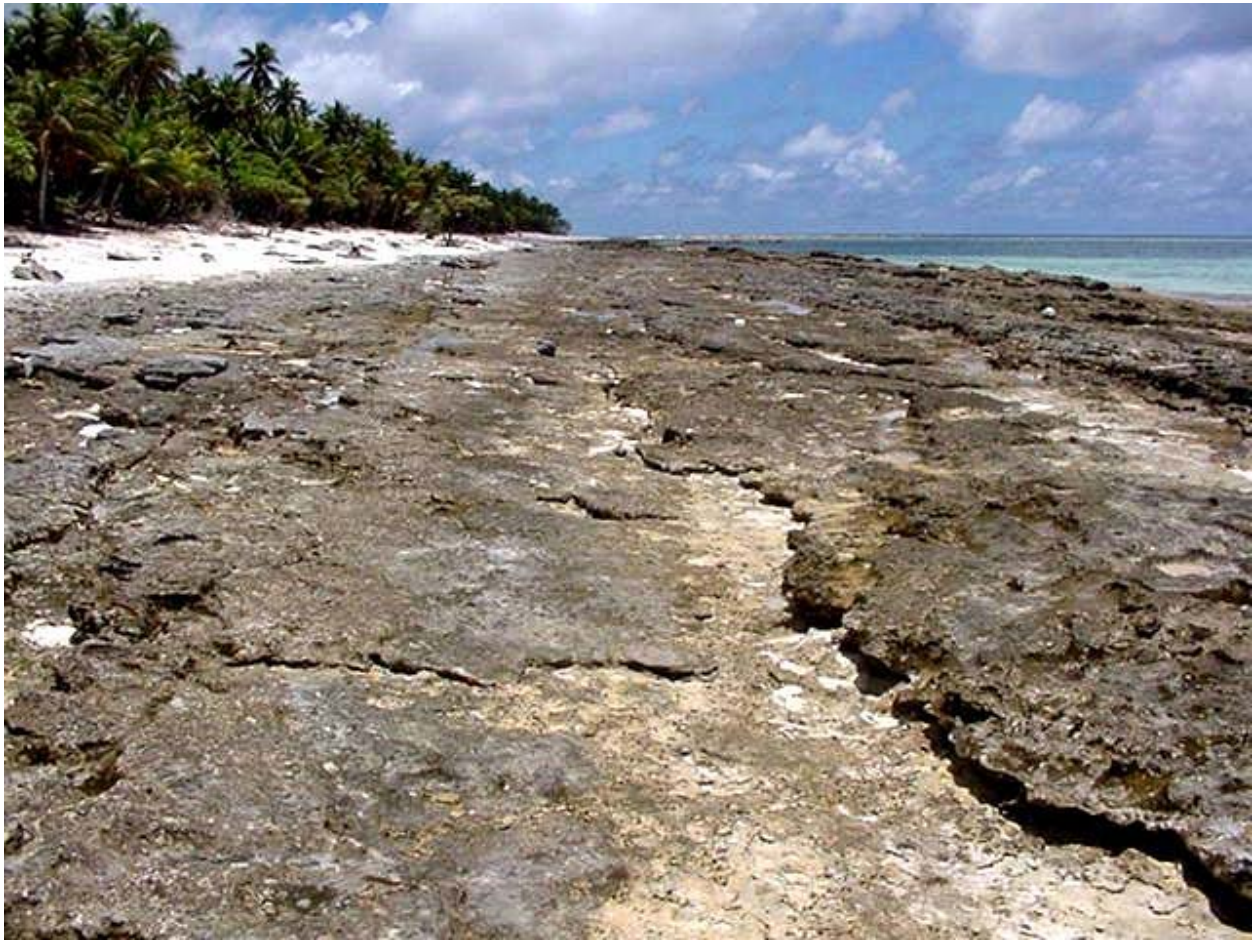
Most of the oil deposits were similar in size and distribution as found on Pao but there seemed to be even less impact on the ledges than what we found on Pao Island. Again, no large concentrations of oil were found.

Figure C-7. Losiep Island Beach Ledges

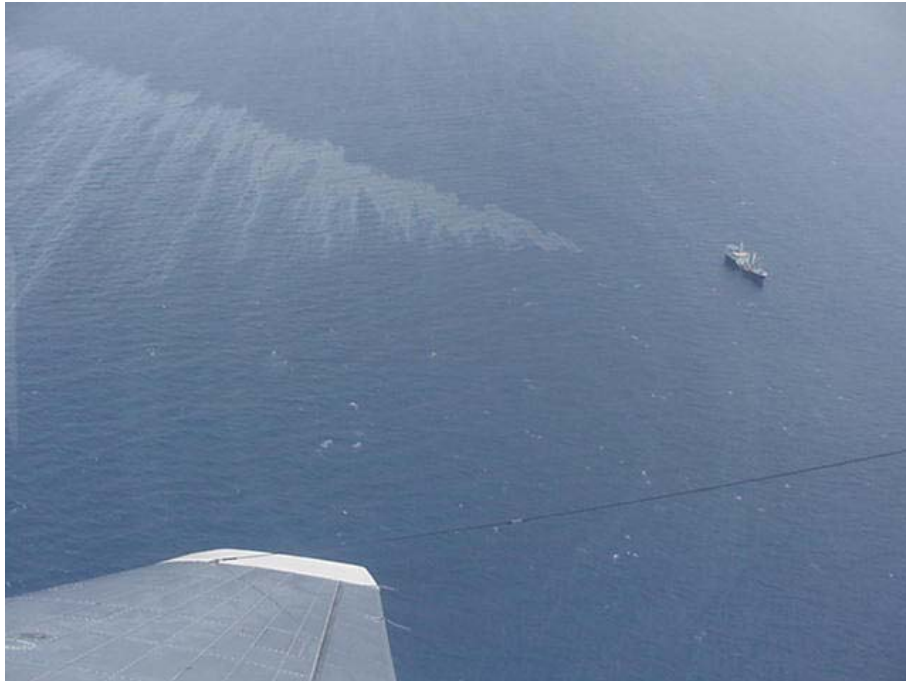
Figure G-1. *Micro Spirit* over Wreck and Slick

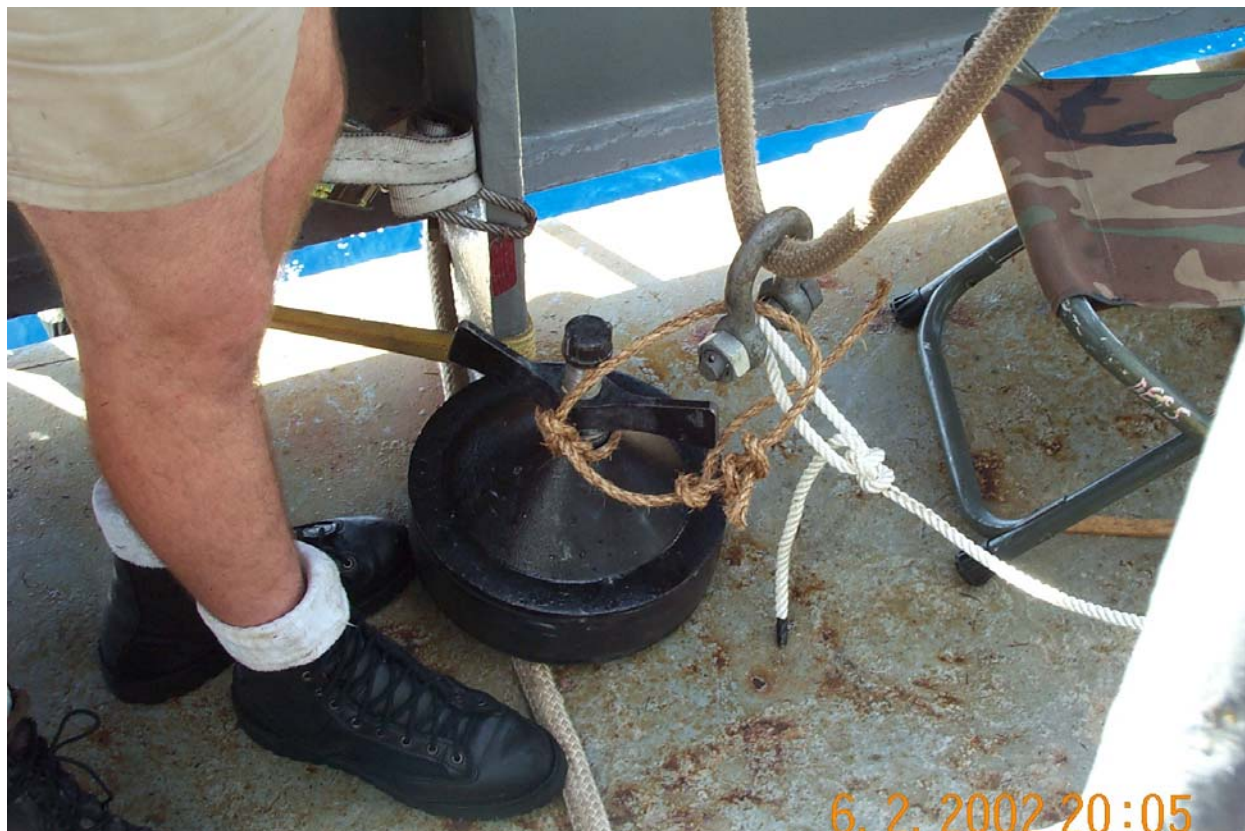
Recovered mostly water from a short pumping of #4 starboard wing tank. The first dive of the day installed a blanking plate over the flange where the valve had been bolted. The pig plug was driven further into the pipe so the plate would fit snug against the flange. The plug, however, still has a 3/8” center rod in it so it could be readily extracted if access were needed in subsequent operations. Pumping operations worked the remainder of the day to extract numerous pockets of oil in the overhead. This diver operation, however, also put a lot of expelled diver air into the overhead, which would become a problem when the divers attempted

Figure 2. Typical Pipe Plug Used

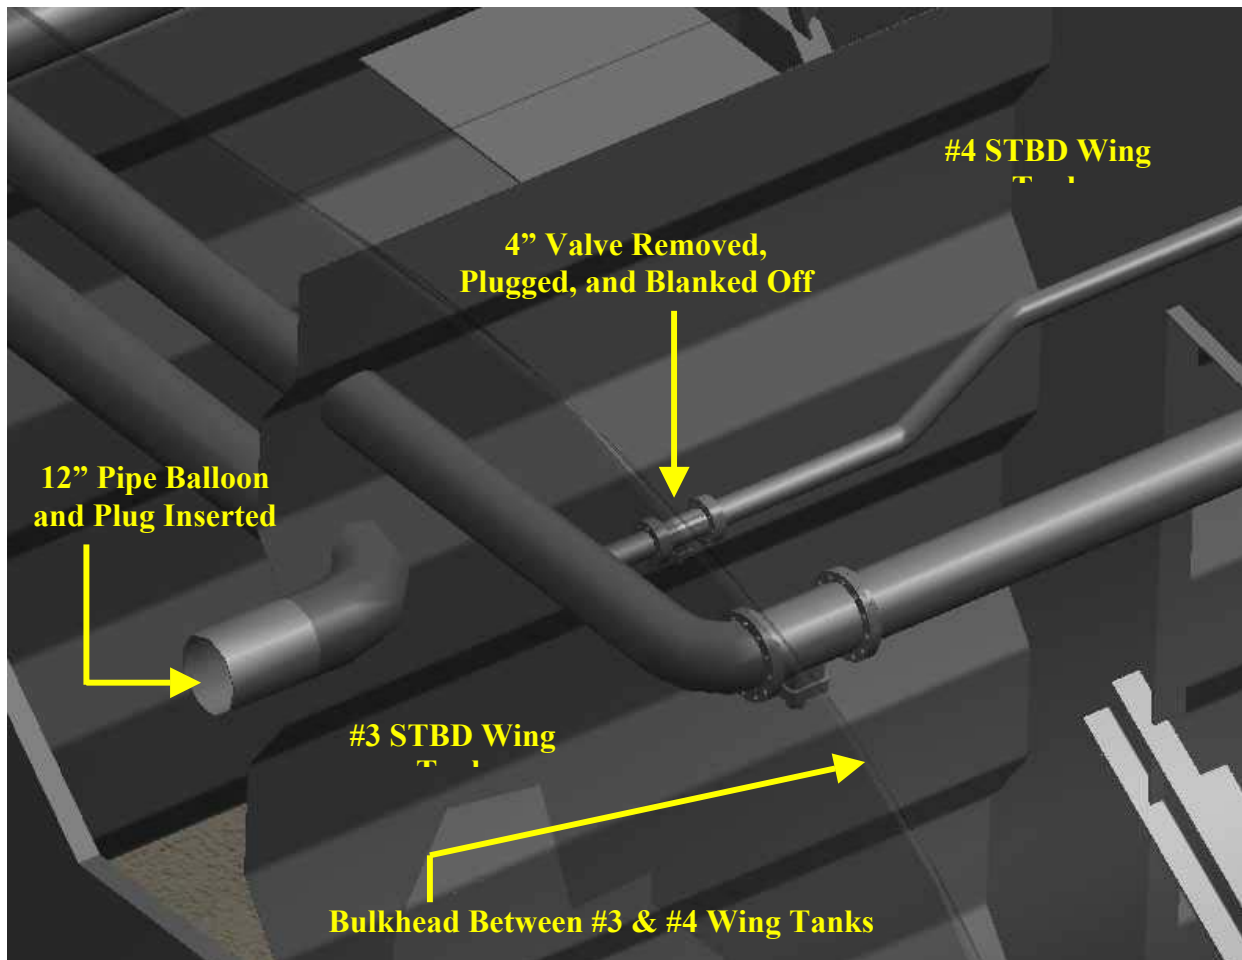
Figure 5. Piping in Number 4 Forward Wing Tank

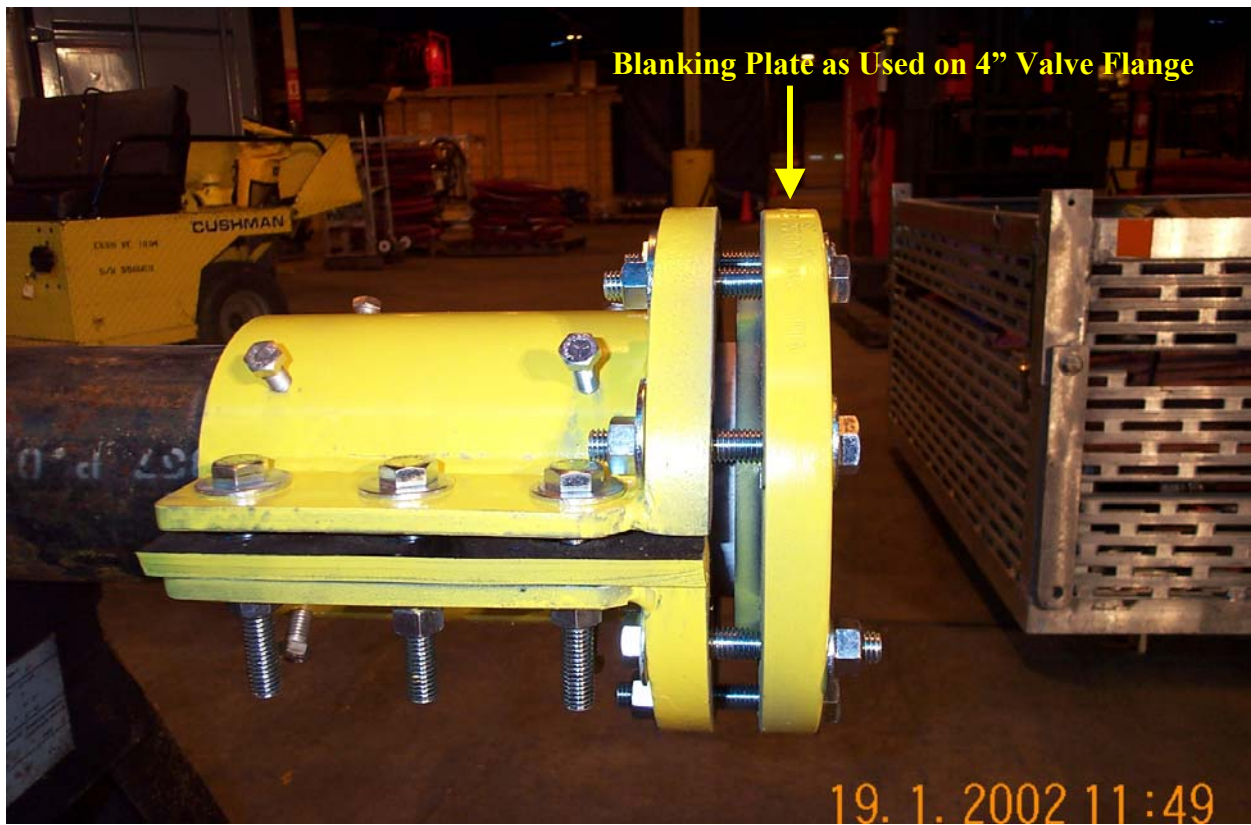
Figure 6. Blanking Plate Completed

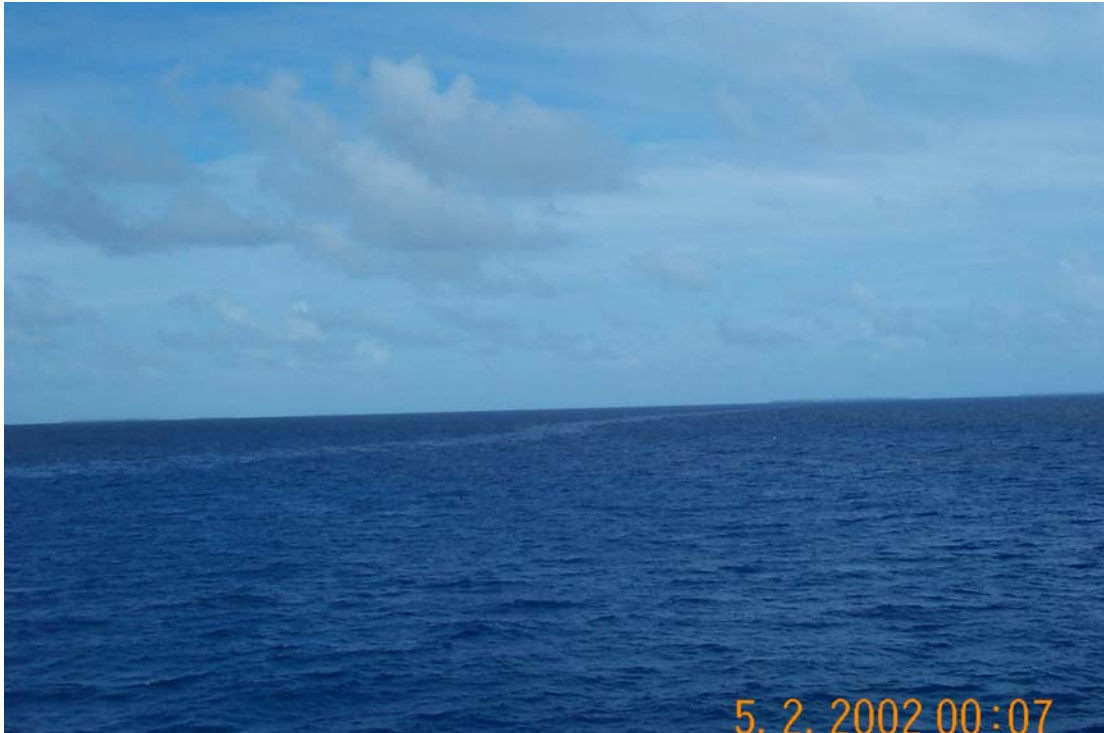
Figure 22. Sheen as Seen on Arrival
